IN THE PROVINCIAL COURT OF NEWFOUNDLAND

A Judicial Inquiry into the Causes and Circumstances surrounding an explosion and fire at the ***Come By Chance Refinery****, Come By Chance, Newfoundland and Labrador, occurring on March 25, 1998 which caused the deaths of Jerome Kieley and James Mercer.*

DATE OF REPORT: *August 8, 2005*

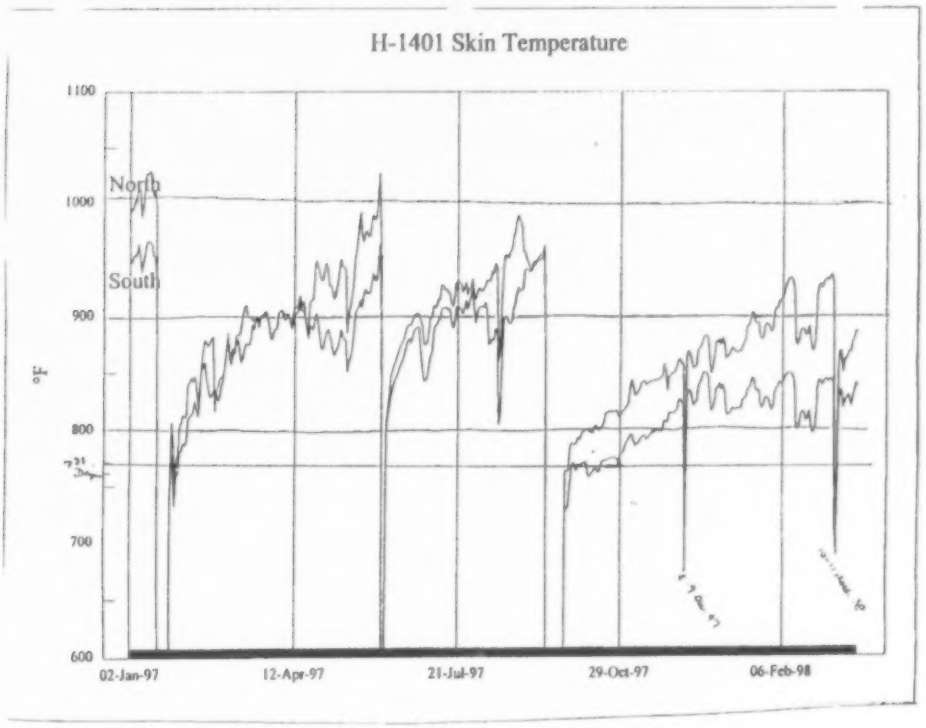
OHS 3 TAB. 9

September 1997. Thereafter, the skin temperatures again rose to approximately 950° just before the middle of March 1998.

From January 1, 1997 until March 25, 1998, the tubes on the north radiant wall consistently had a higher skin tube temperature than those on the south radiant wall of heater 1401.
